# BAPROLA

Resettlement Colony, West Delhi

## STRUCTURAL ASSESSMENT

A Report on the Problems & Solutions

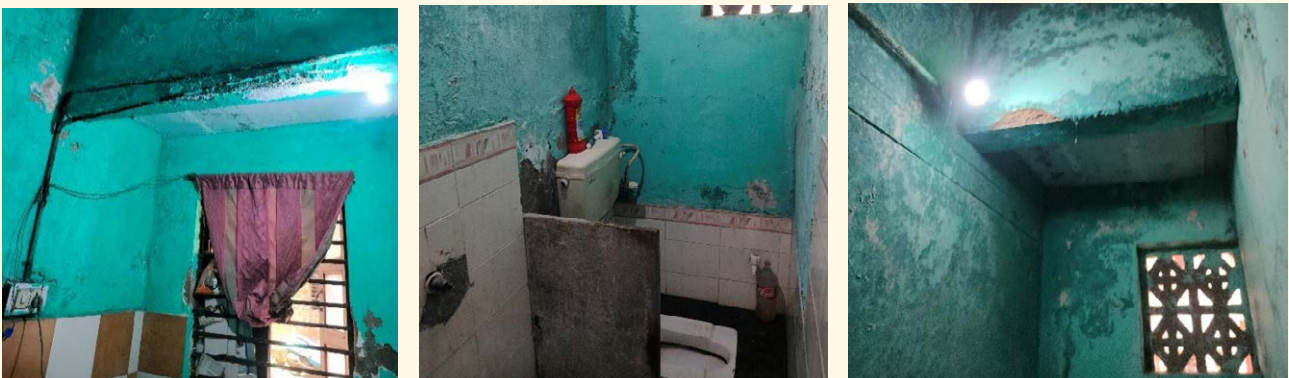
- ▶ In all blocks, without fail, the internal and external walls, especially in the kitchen and toilet zone, have a major seepage problem
- ▶ The seepage is causing dampness on the walls, resulting in flaking of paint inside the dwelling unit and deterioration of bricks on the facade

*Figure 7: Seepage and moisture on interior walls, ceiling, toilet in a home*

- ▶ Poor quality plumbing work inside toilets and kitchens
- ▶ Broken sewer and rainwater pipes
- ▶ Rusting of GI water supply pipes when exposed on the exterior

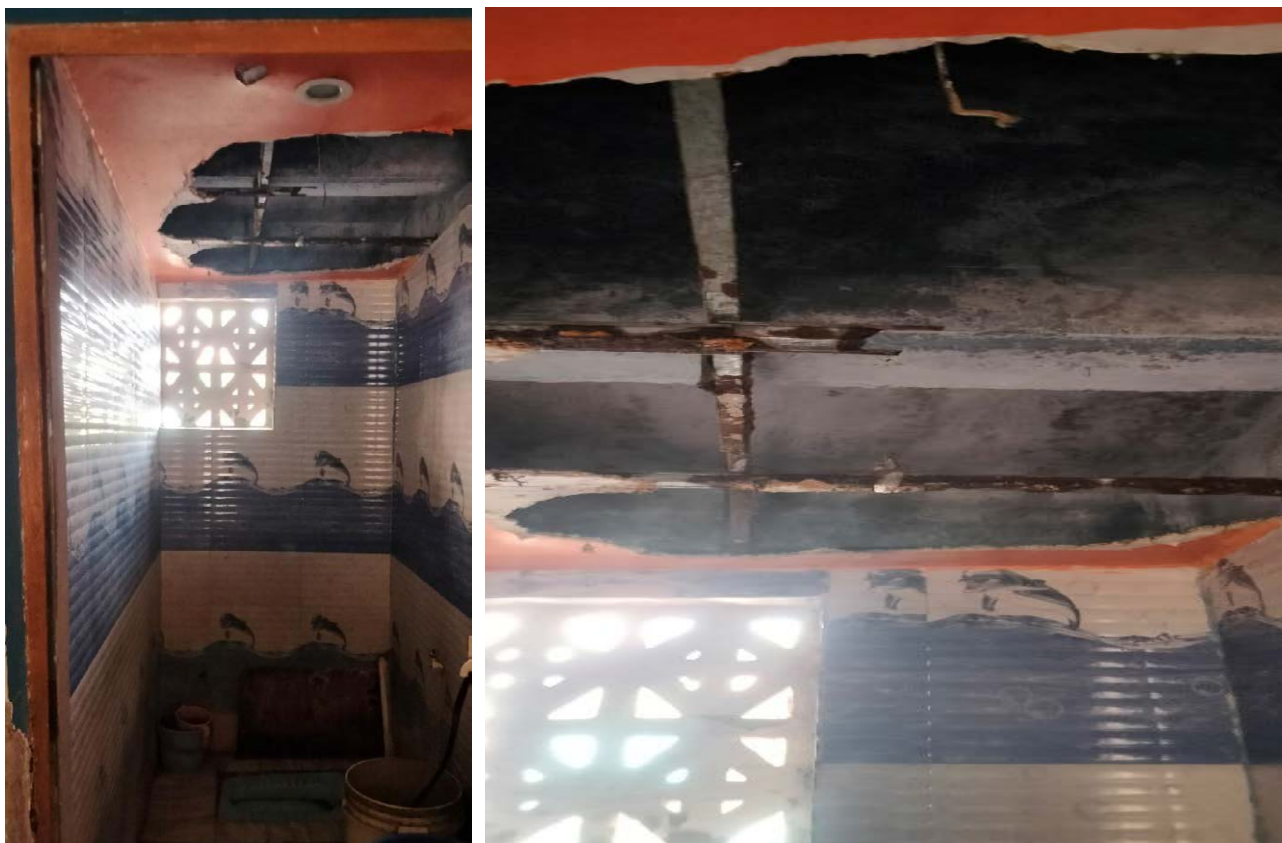
*Figure 8: Deterioration of ceiling due to seepage*

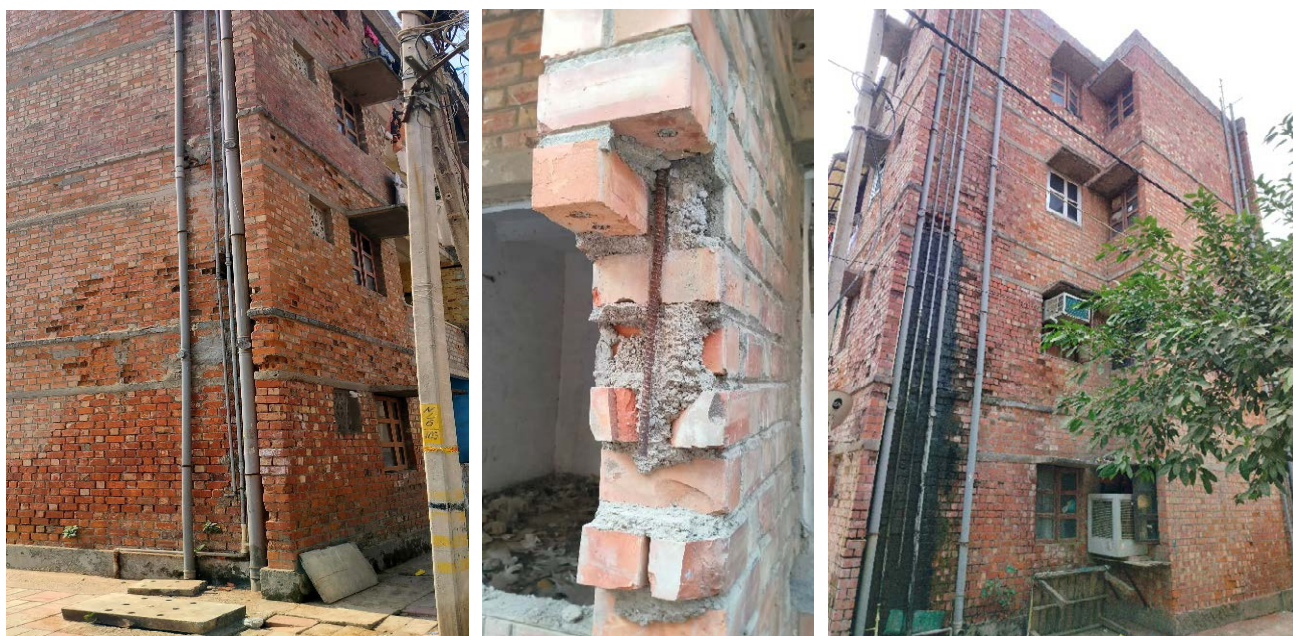
*Figure 9: Seepage on external walls, deterioration of bricks*

1. Repairing damaged bricks either through replacement or repair with plaster/micro-concreting
2. Painting repaired-brick surfaces. Plastering the walls till the second floor is necessary, while the third floor can be plastered if there is a risk of water seepage from the terrace

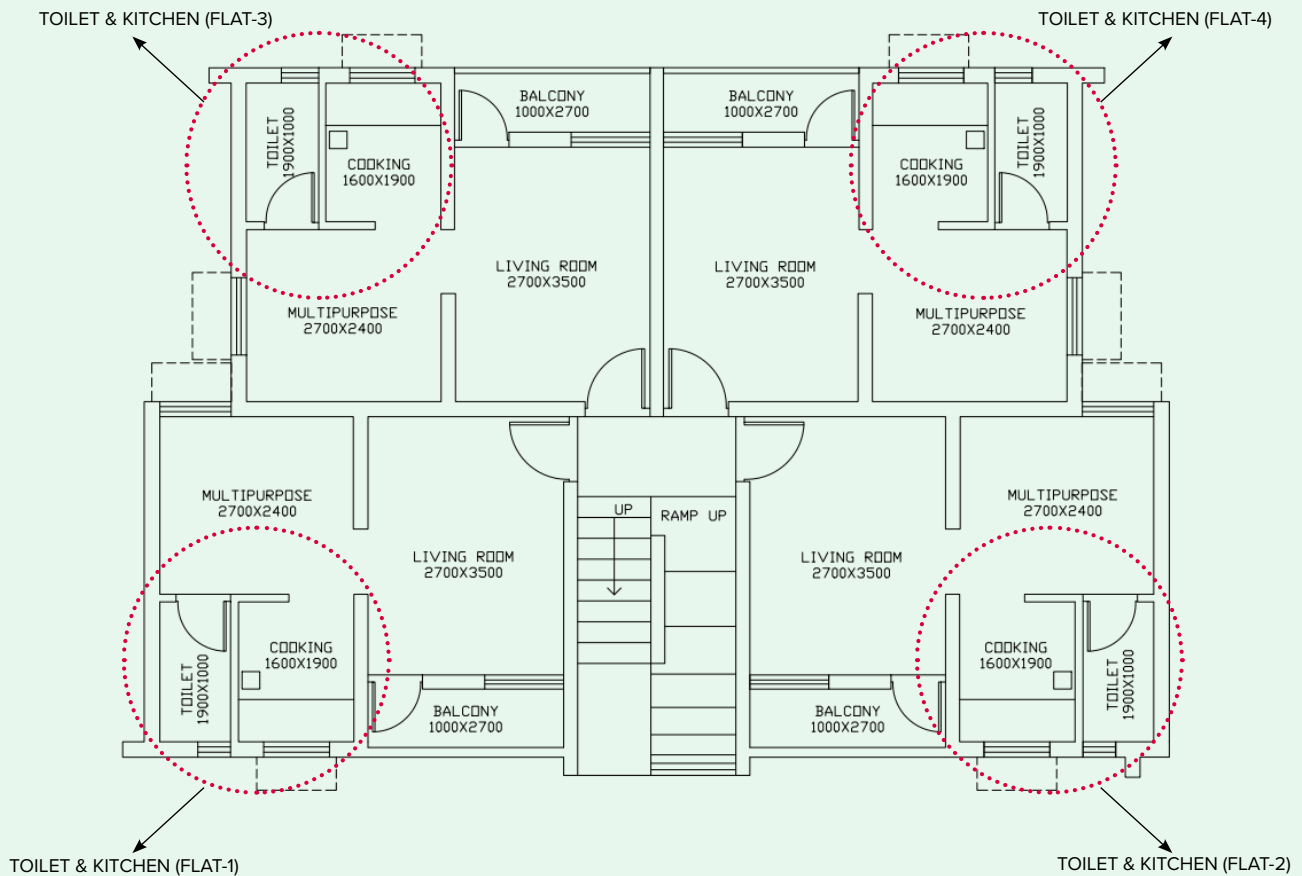
The diagrams below show the areas of damage in the internal and external walls of the building blocks, through the floor plan and elevation of a standard block. The diagrams show that the majority of damage has been sustained in the toilet and kitchen areas, both internally and externally.

Figure 10: Block plan showing affected areas inside flats

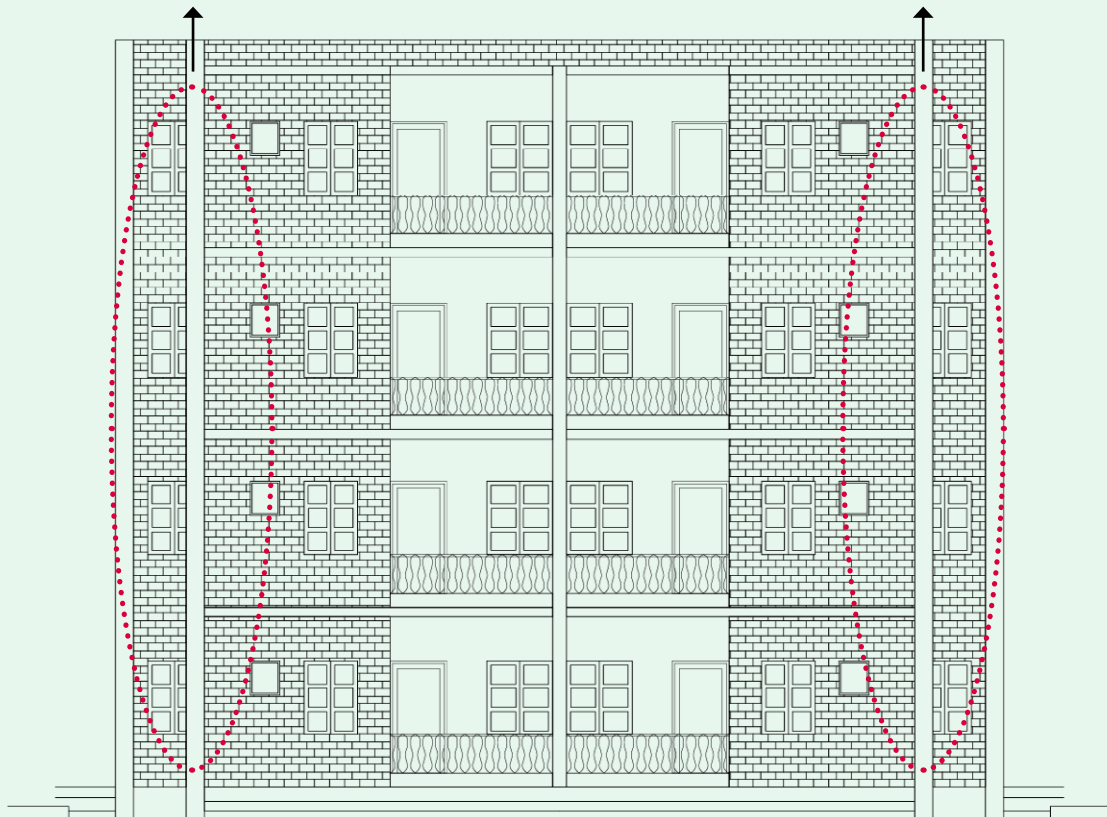
### MAJOR DAMPNESS ON EXTERNAL WALLS OF TOILET & KITCHEN AREAS

Figure 11: Block elevation showing affected wall surfaces

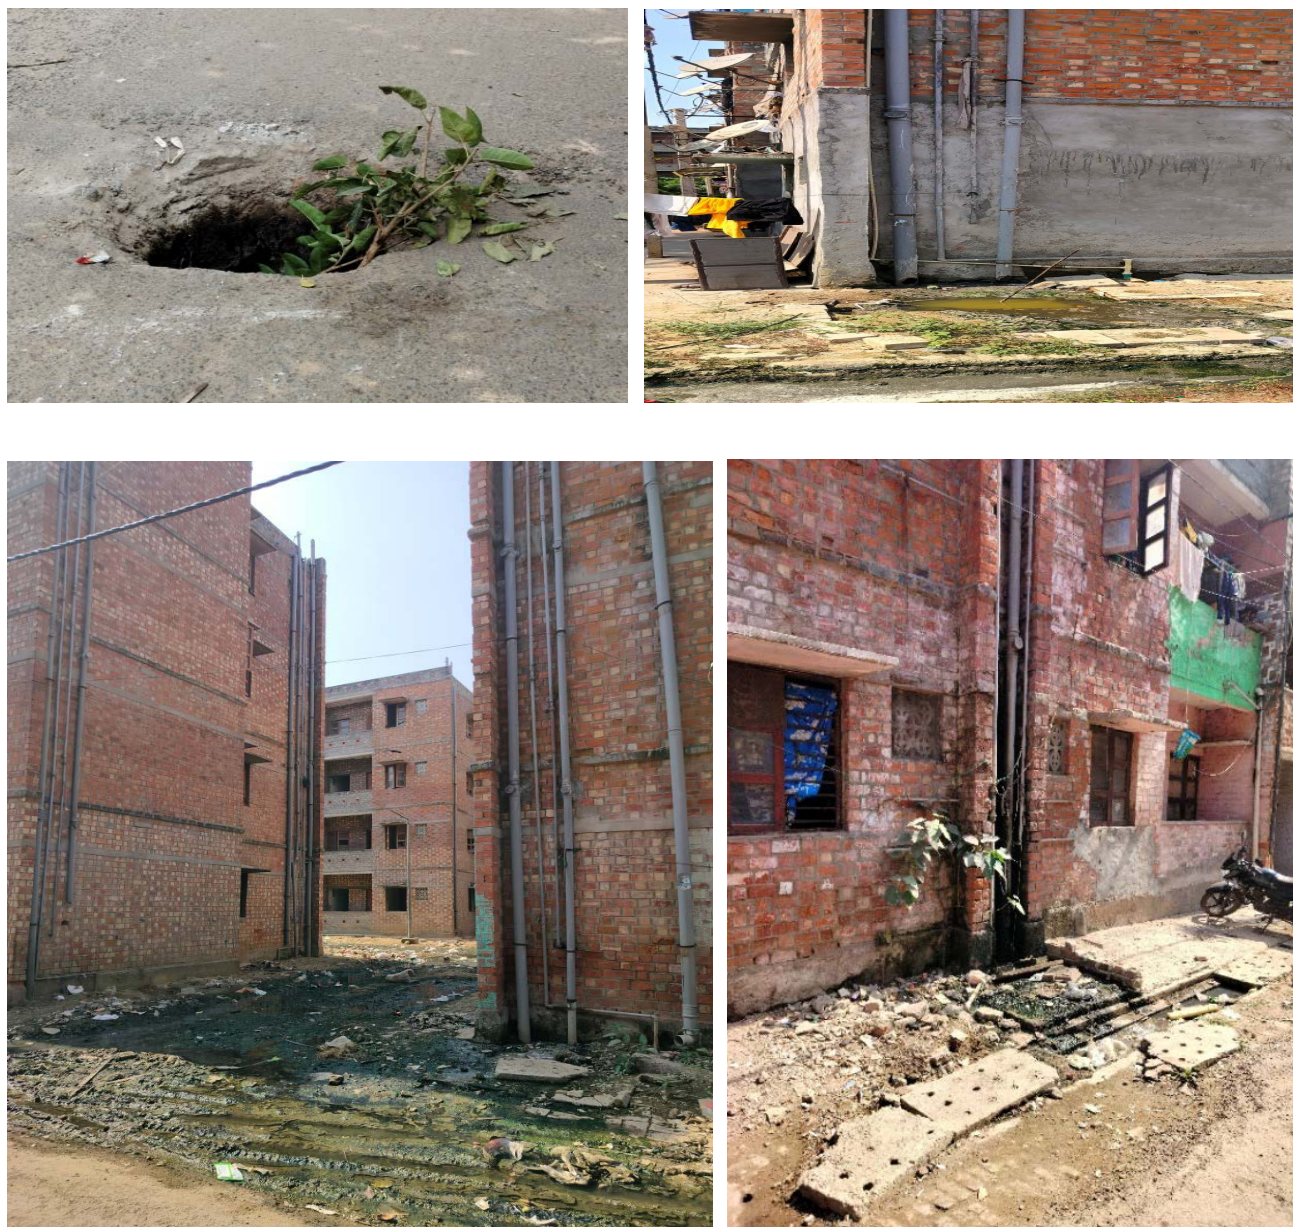
- ▶ Choked sewer lines and stormwater drains
- ▶ Broken and/or absent manhole/drain covers
- ▶ Seemingly non-functional septic tanks
- ▶ Pumps of septic tanks stolen

Figure 12: Overflowing sewage and storm water drains, missing/broken drain covers

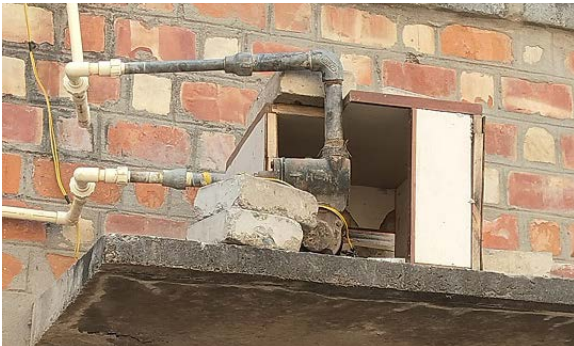
People who could afford it have set up their own motors (Figure 11) to bring water up to the third floor, but this has been done in an ad hoc manner and is not a feasible universal solution.

*Figure 13: Motor installed by resident*

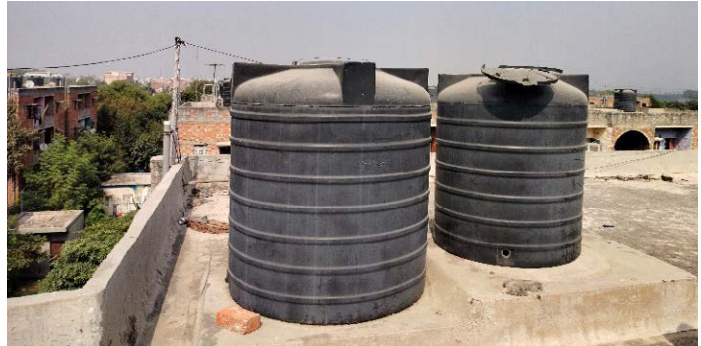
*Figure 14: Water tanks unused on terrace*

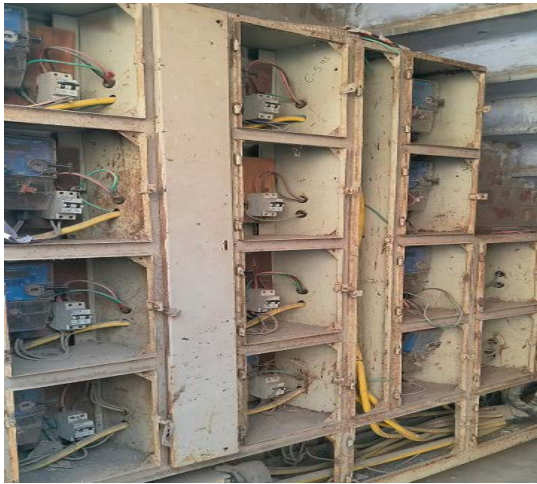
*Figure 15: Electric meter boxes exposed because covers stolen*

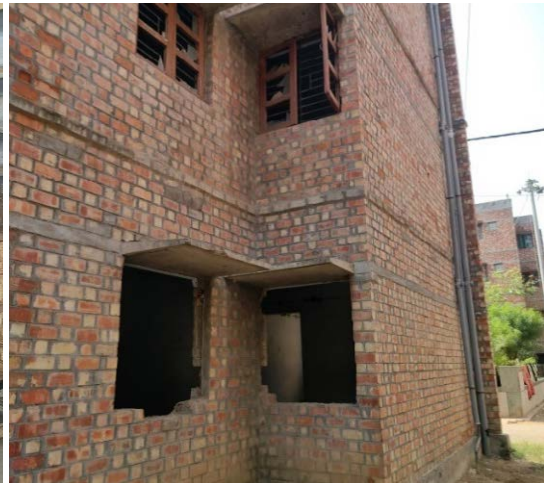
*Figure 16: Windows & grills stolen from unoccupied flats*

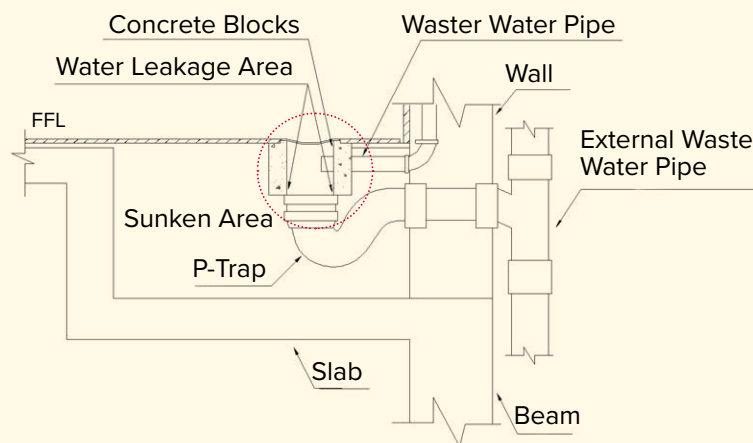
1. Water seepage through the concrete block corner due to high-pressure wastewater from the open drain pipe

*Figure 17: Water seepage through the concrete block corner due to high pressure waste water from the open drain pipe*

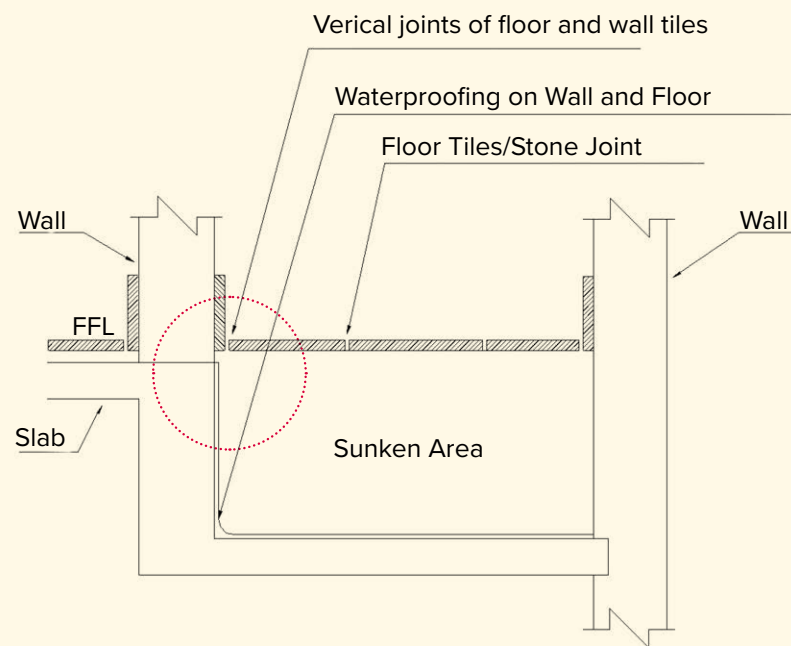
## 2. Improper floor and dado tile junction and tiles/stone joint leading to seepage

*Figure 18: Improper floor and dado tile junction and tiles/stone joint leading to seepage*

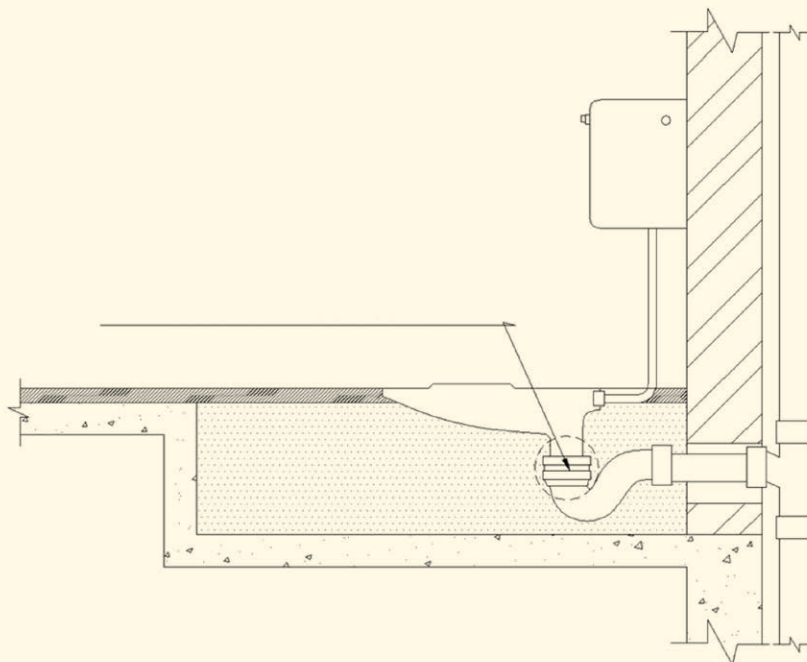
## 3. Improper joint between the WC and P-Trap resulting in seepage

*Figure 19: WC and P-Trap improper joint leading to seepage*

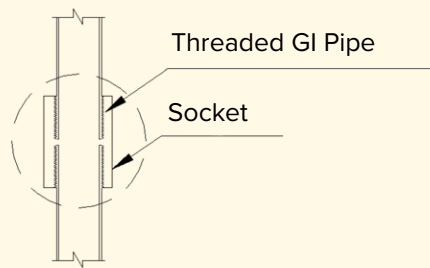
4. Water supply in the dwelling units is through GI pipes, which corrode easily

*Figure 20: Galvanising gets off the threaded GI pipe leading to corrosion of the pipes*

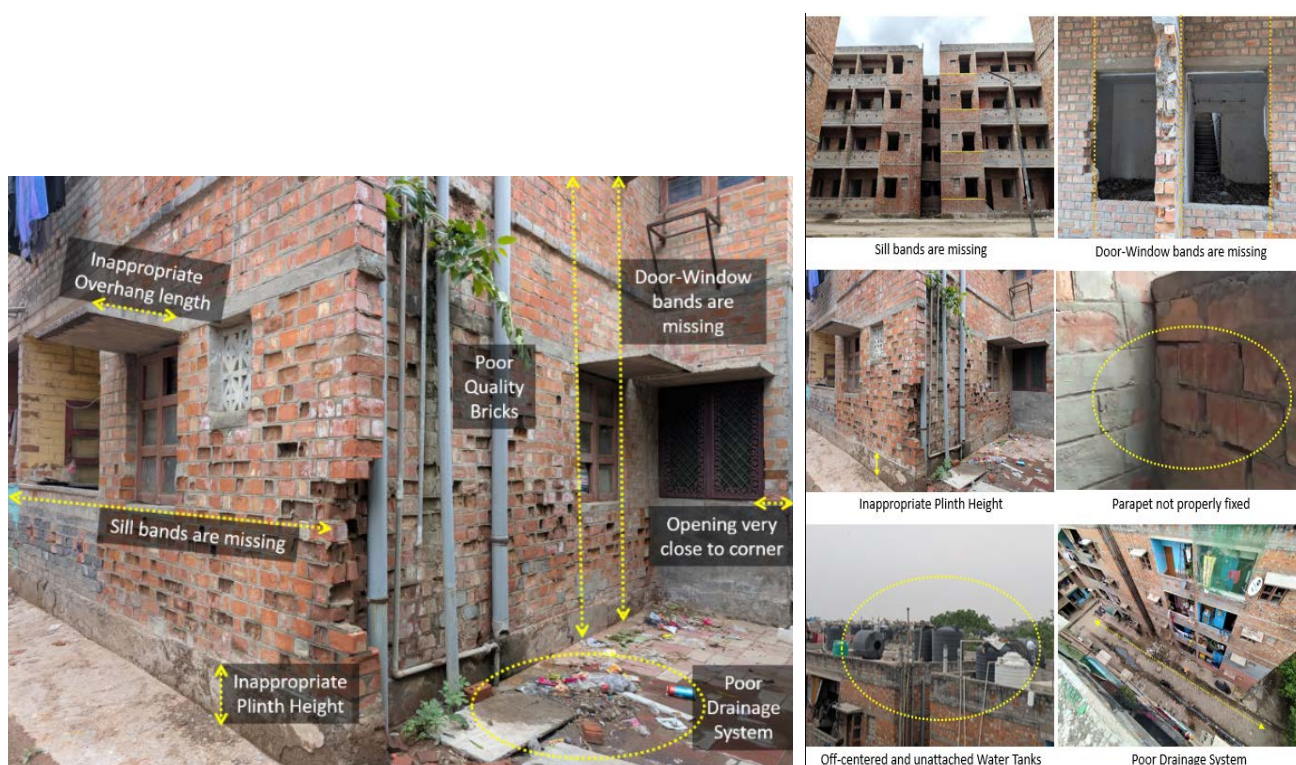
The colony's buildings are G+3 load-bearing brick masonry structures exhibiting multiple signs of structural distress and environmental wear. Only plinth and lintel bands are present, with no sill band or roof band as recommended for high seismic zones.

- ▶ Cracks near openings, indicating stress concentration and seismic vulnerability
- ▶ Delamination of plaster in interior walls and brick peeling in exterior walls, caused by moisture ingress and poor-quality materials
- ▶ Damp walls, fungal growth, and indoor moisture accumulation, reflecting insufficient waterproofing and drainage
- ▶ Poor quality construction and material degradation
- ▶ Cracks in the walls

Figure 25: Issues to be addressed for earthquake resilience

- 2. Wall Strengthening and Crack Treatment:**
  - a. Stitch existing cracks using cement grouting for superficial cracks and structural epoxy injections for deeper structural cracks.

- b. Apply a retrofitting mesh on both sides of the walls for added confinement.
  - c. Re-plaster the interior walls with cement mortar mixed with waterproofing additives to prevent further moisture ingress.

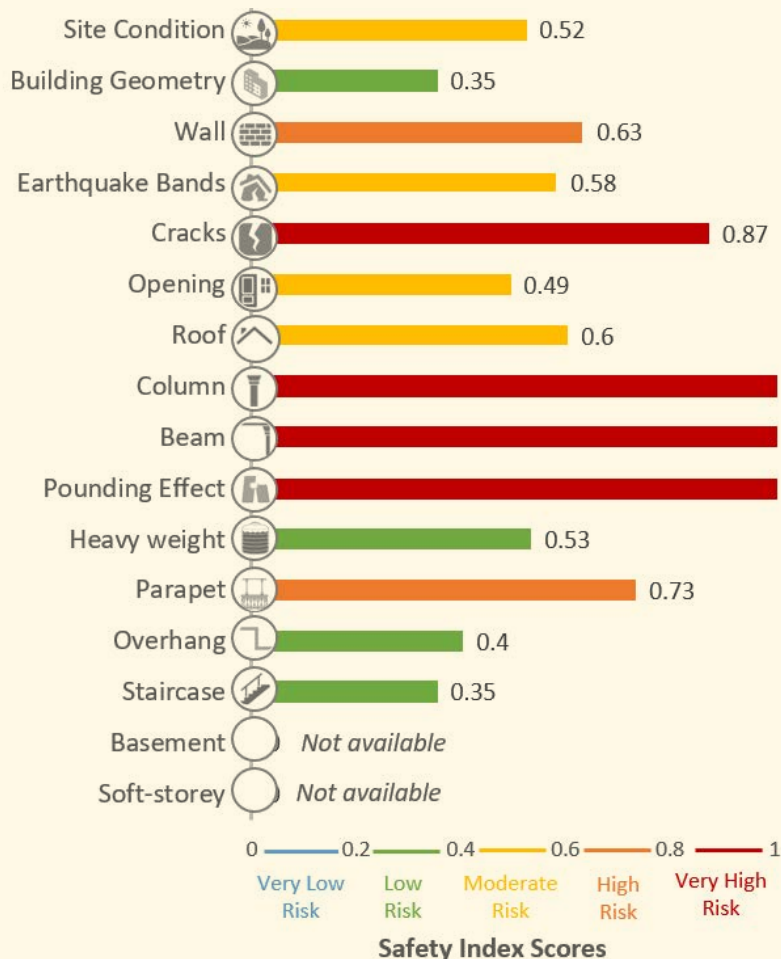
Figure 26: Safety Index Scores of Building Components

Based on the field assessment, the building's seismic vulnerability was evaluated through component-wise scoring, as illustrated in the accompanying figure (Figure 26). The assessment indicates high risk in components such as walls, due to excessive dampness and structural cracks, columns and beams, due to their absence, and parapets, due to their poor condition.

With an **average safety index score of 0.60**, the building is categorised as highly vulnerable, primarily due to the absence of critical seismic features and visible signs of material deterioration.
